MTBE and the Future of Clean Water in Lakeside, California

**San Diego River in Santee (907.110) – 303(d) Fact Sheet
Fish Kill Report from the R9WQCB (L. Brown)**

SUBJECT: Fish kill in the San Diego River in Santee, reported August 30, 2000

San Diego River 907.12 at Old Mission Dam

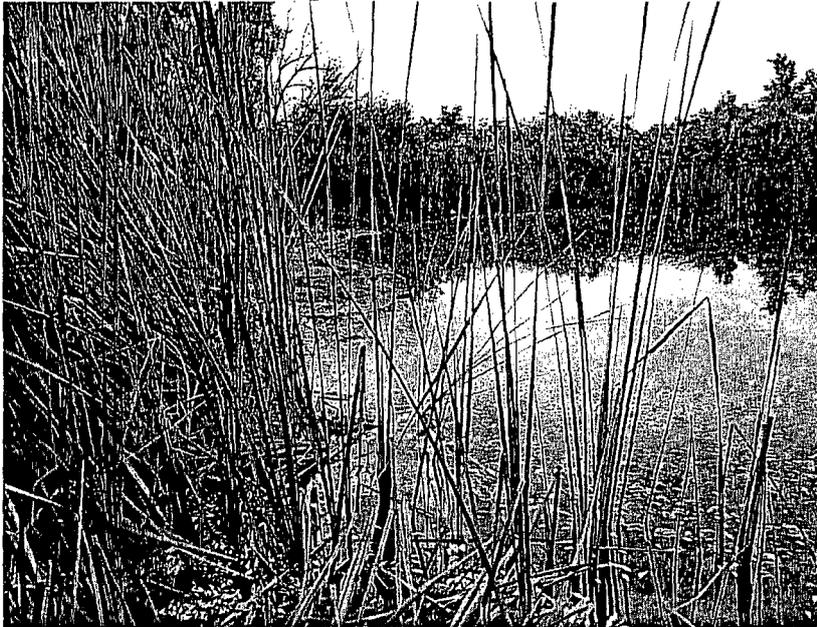
Looking towards the Southeast

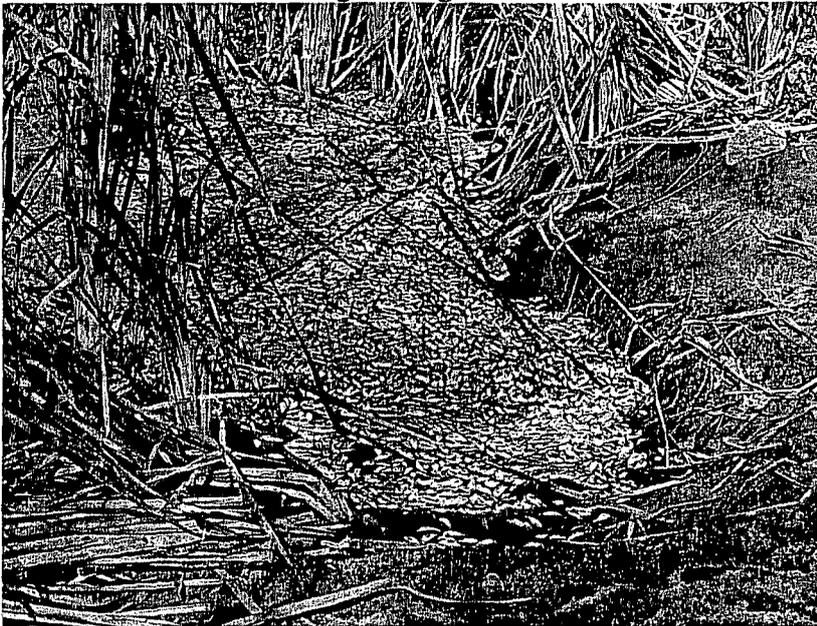
A site visit was made on August 31, 2000 in response to the report of a fish kill potentially due to an illegal dumping of pesticide. A band of dead fish (shad) was observed around the edge of pond feature of the river. A few large fish (catfish, bullhead, bass, and bluegill) were also found dead in an isolated spot. Algae were also present at the edges of the pond. Numerous live fish of a different species from those that had died were observed swimming near shore. I spoke with a fisherman on scene. He said that there were dead fish all the way around the pond, however it was to a lesser degree on the north and west sides. The worst of it was on the eastern side.

Dead Shad
Note green algae/muck

Based on the above information, this fish kill can be attributed to a shallow pond turnover, which created a low dissolved oxygen condition, killing the fish and causing the odor, and not a pesticide spill.

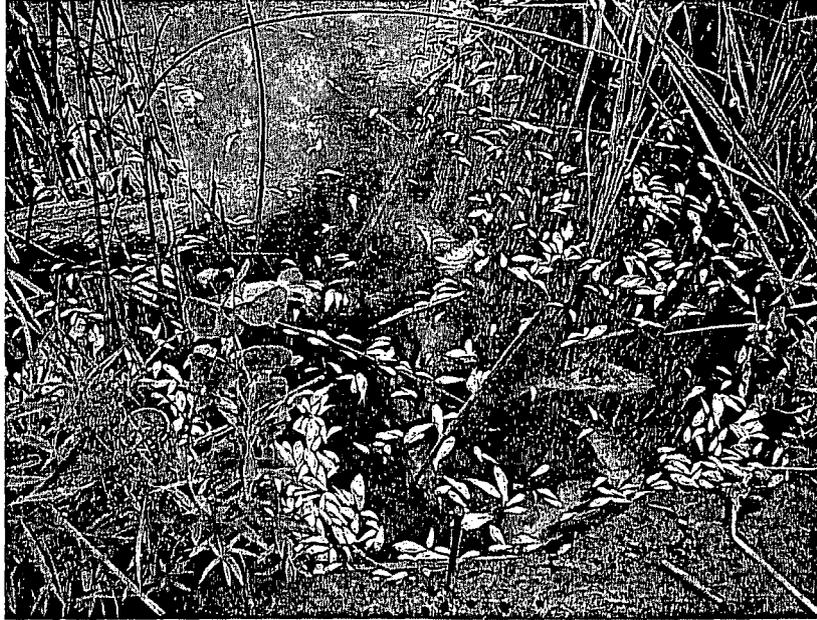
Large dead fish on Southeast side

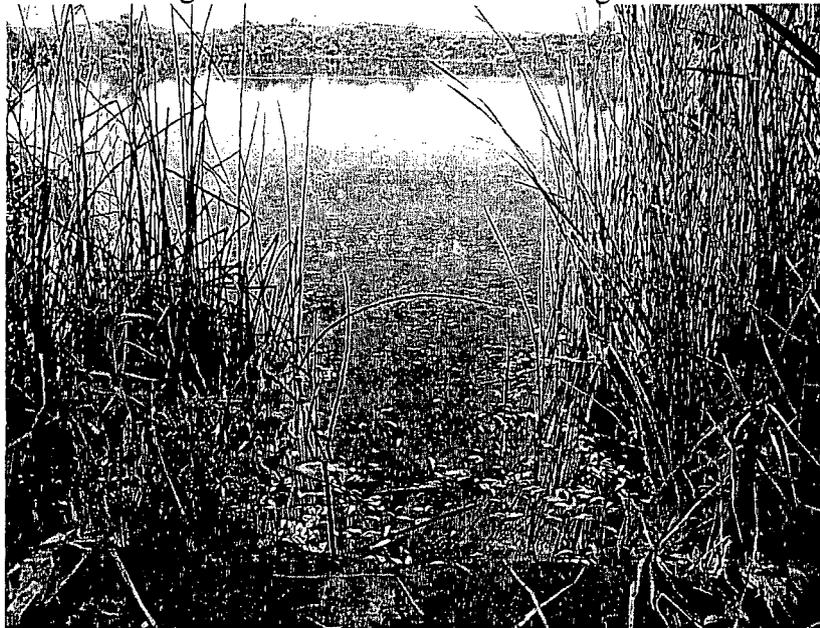
Looking Northwest from location of large dead fish

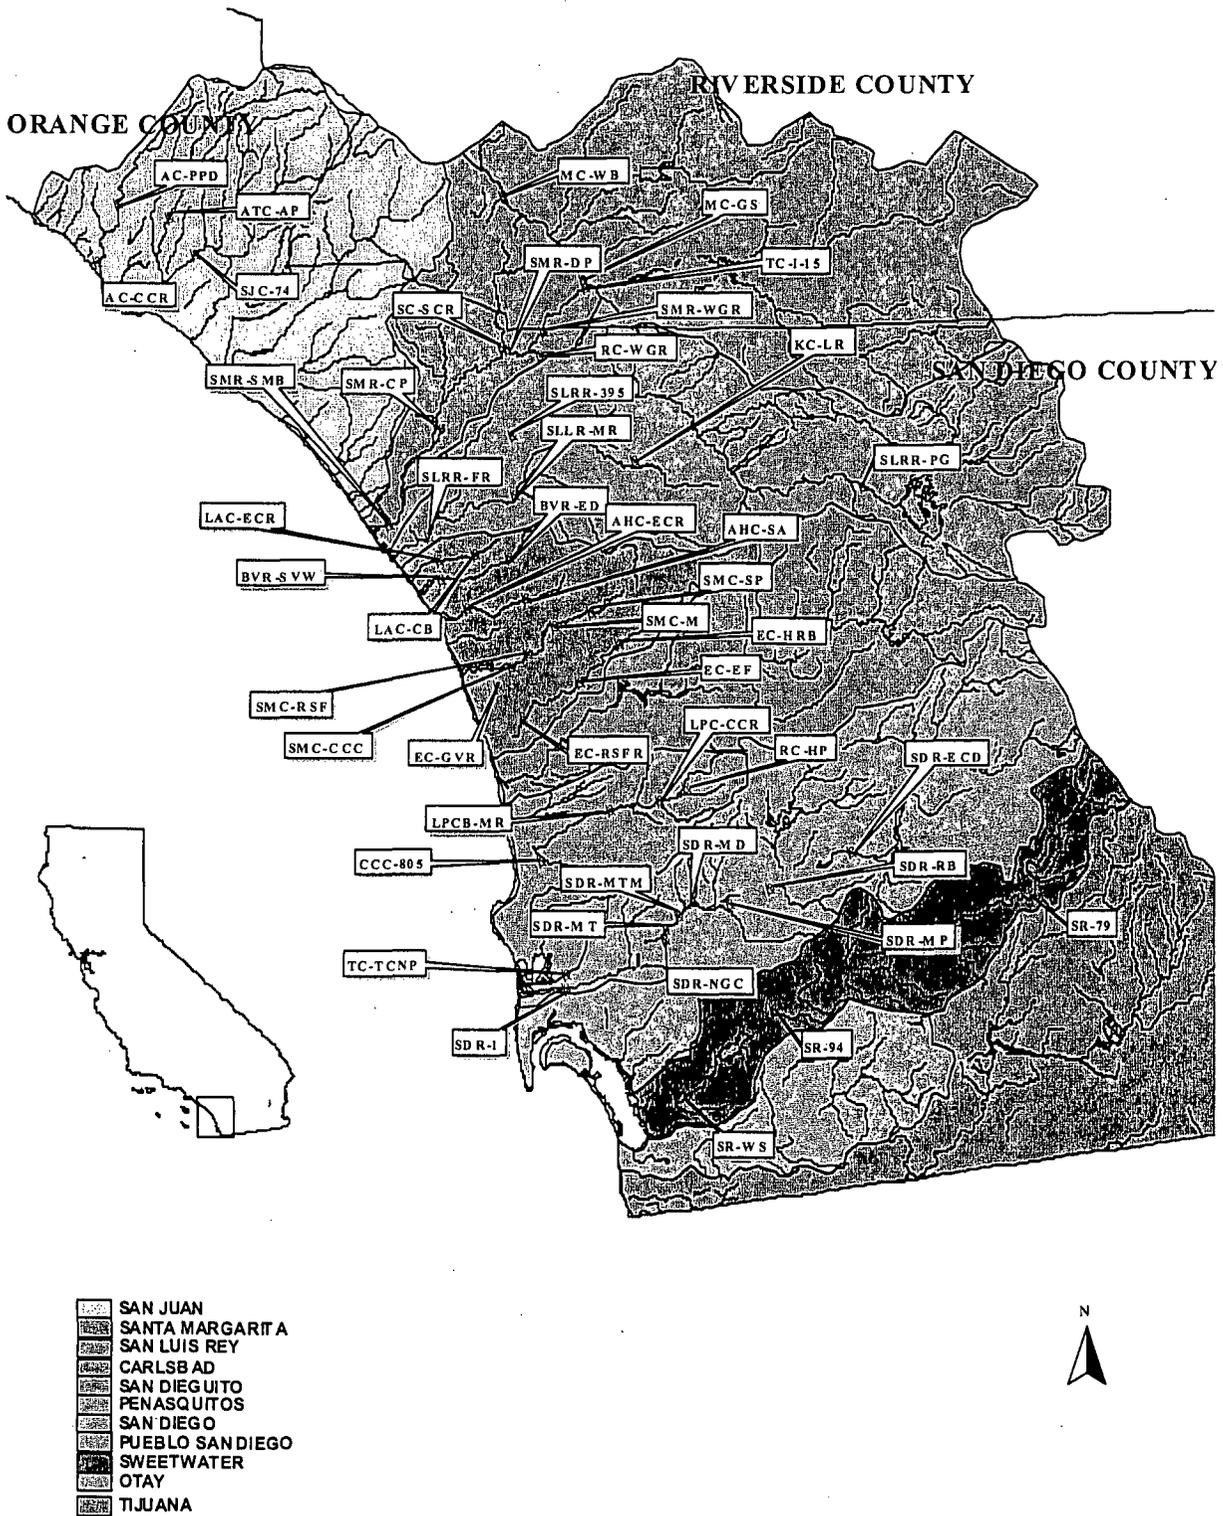
Figure 1. Bioassessment sampling locations within the San Diego region showing major watersheds.

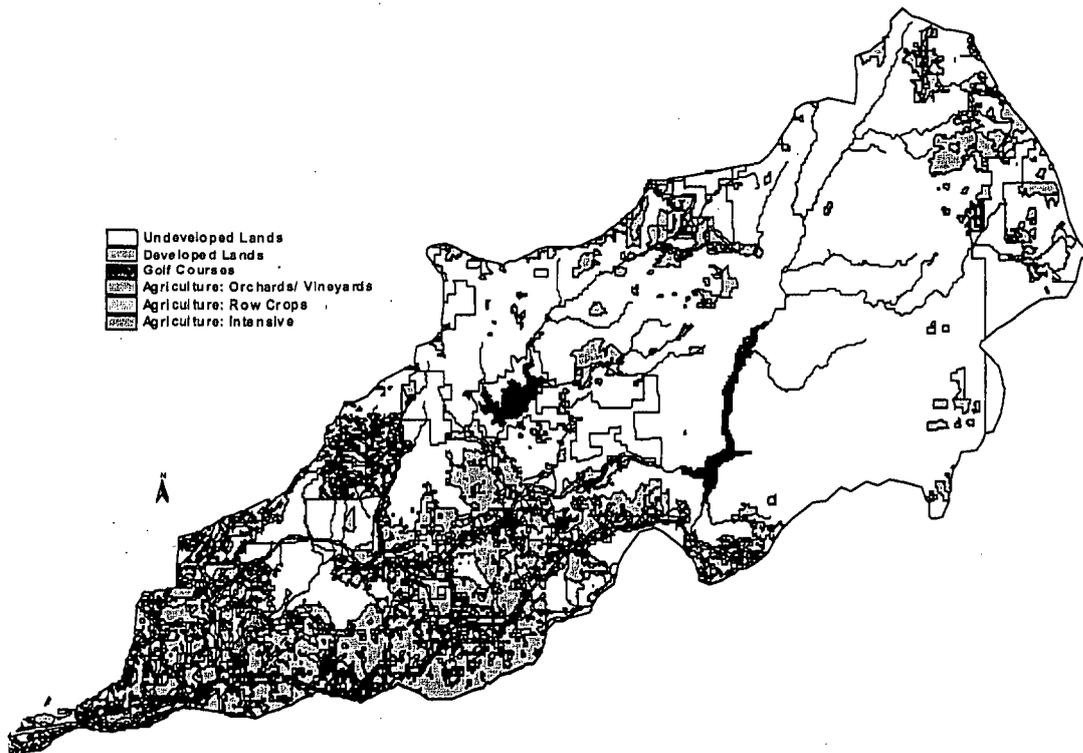
Figure 2. Watershed map of site SDR-1 showing the distribution of major land use categories in the watershed.

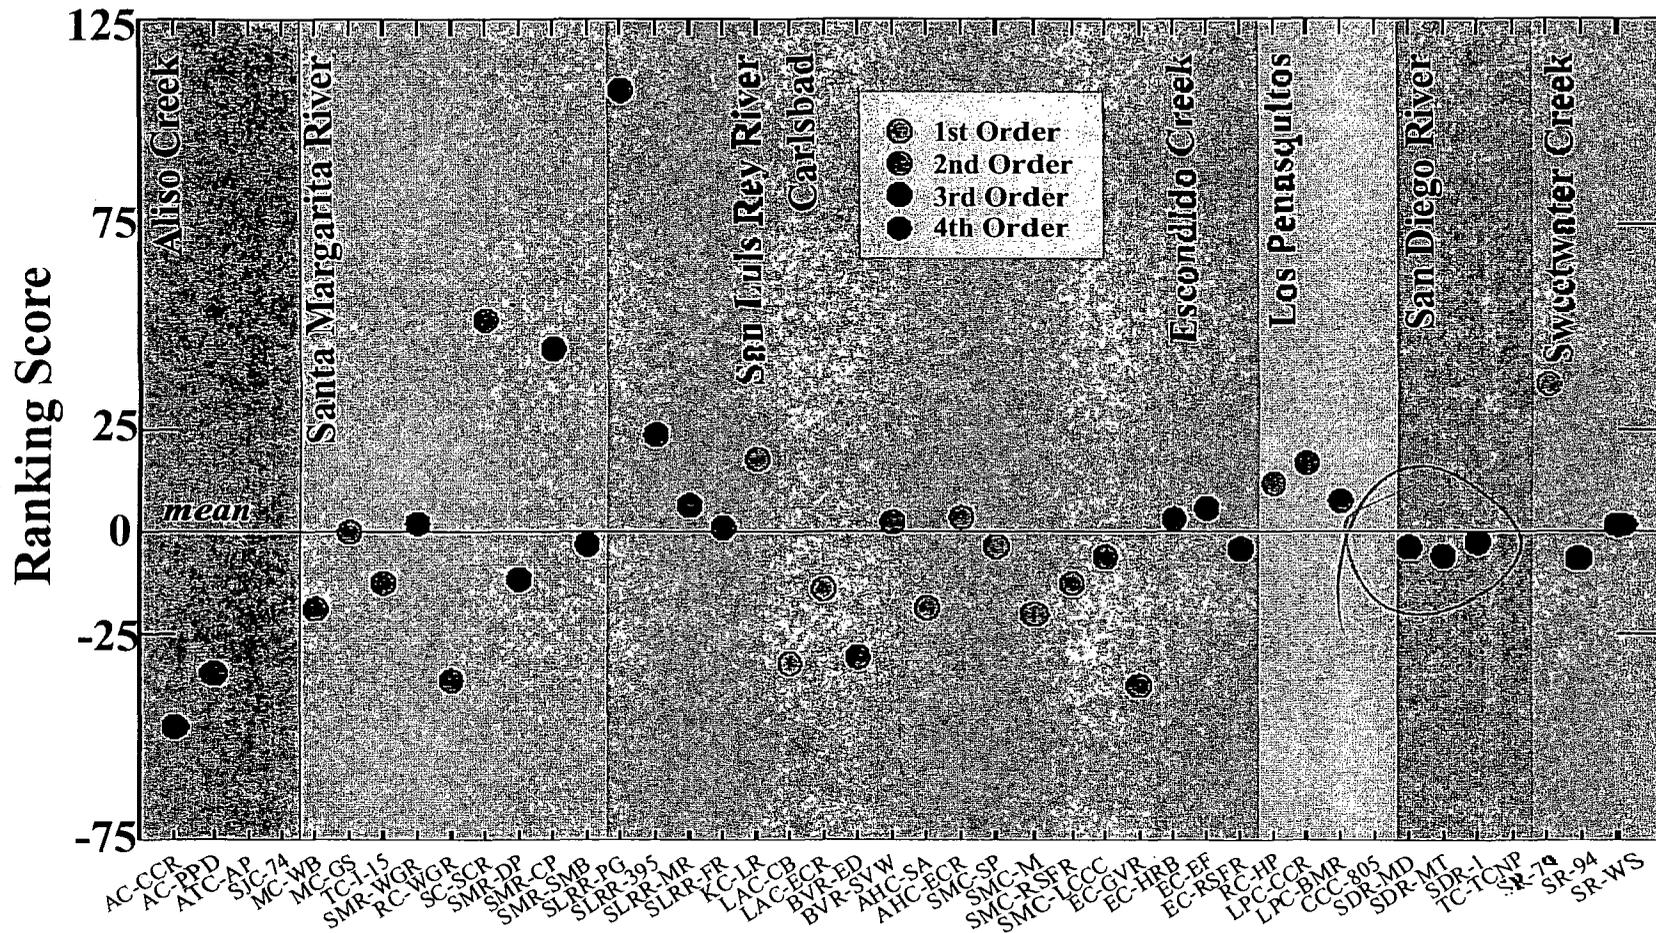
Figure 3a. BMI ranking scores for macroinvertebrate monitoring sites sampled in May 98 for the San Diego Regional Bioassessment Monitoring Project.

The BMI ranking scores were calculated independently for each sampling event and are presented in Figures 3a-3d. Sites are grouped by major watershed unit and color-coded to indicate stream order at each site. In each figure, the "mean" line represents the average rank score of all sites. The rank scores are relative to each other and are only comparable within a sampling event and not comparable among sampling events.

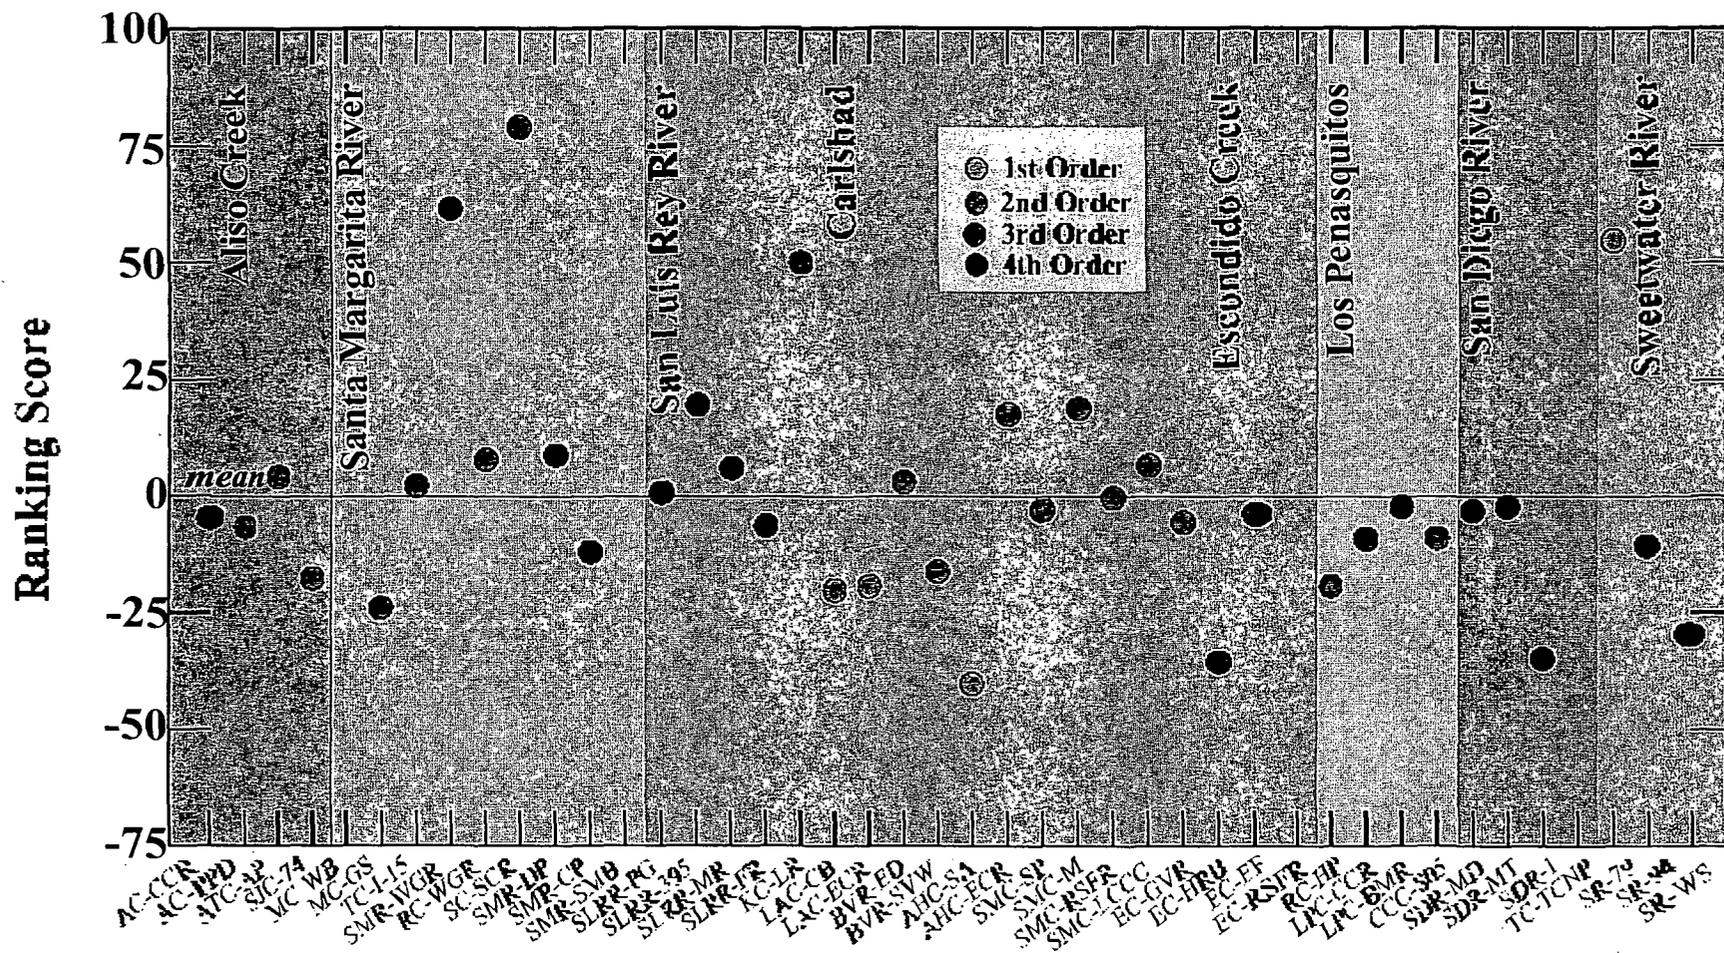
Figure 3b. BMI ranking scores for macroinvertebrate monitoring sites sampled in September 98 for the San Diego Regional Bioassessment Monitoring Project.

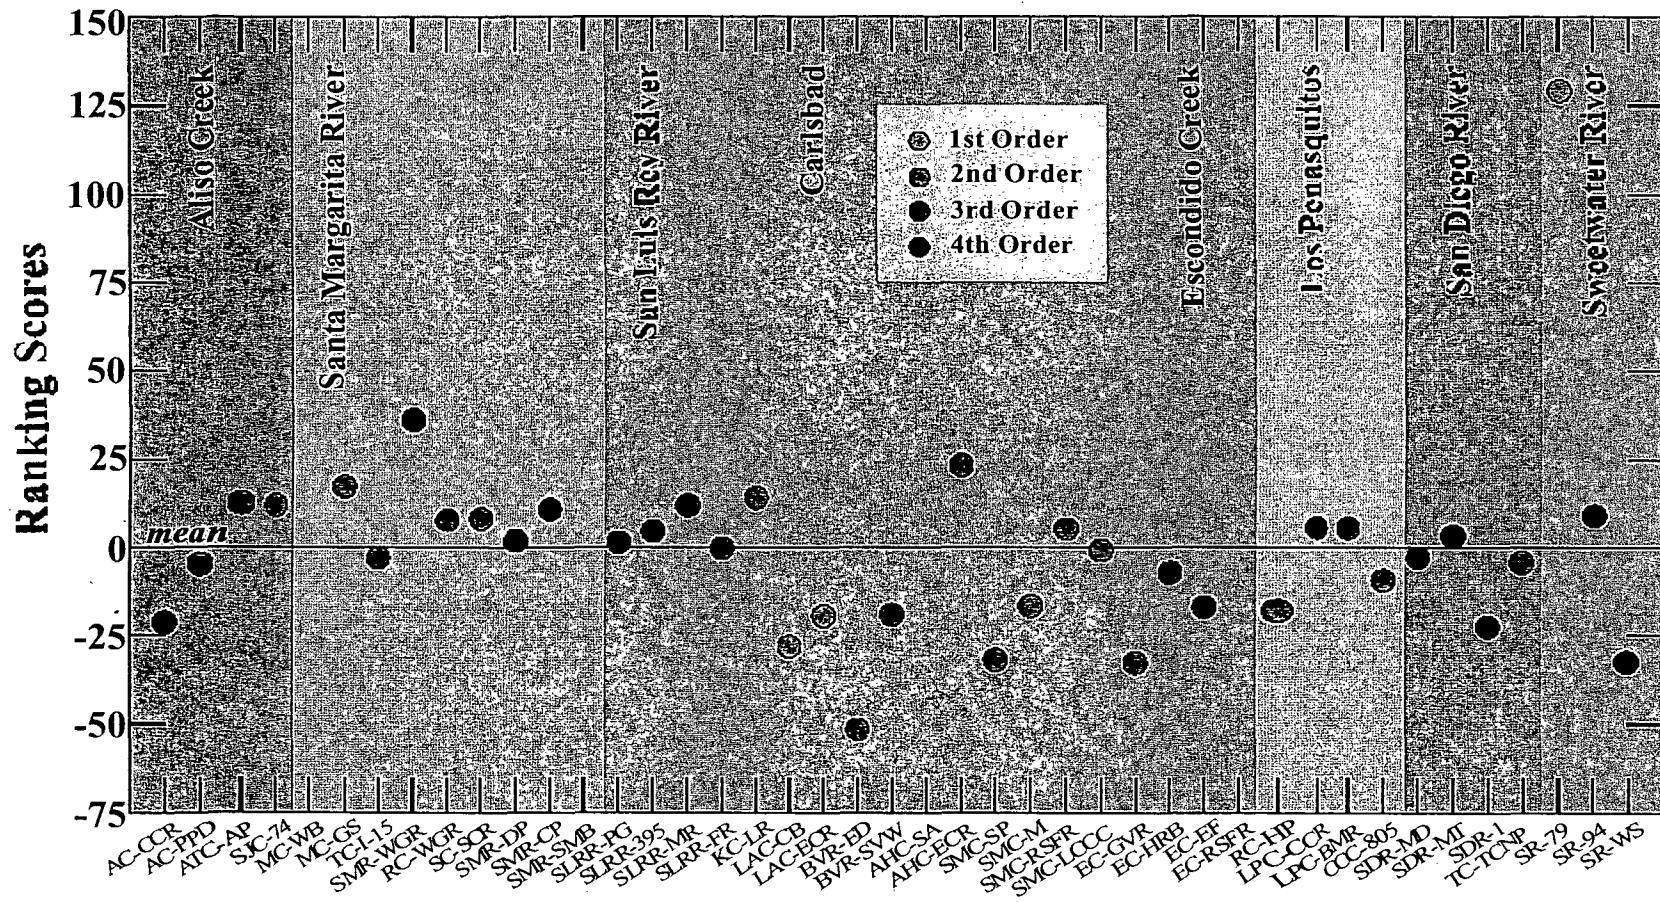
Figure 3c. BMI ranking scores for macroinvertebrate monitoring sites sampled in November 98 for the San Diego Regional Bioassessment Monitoring Project.

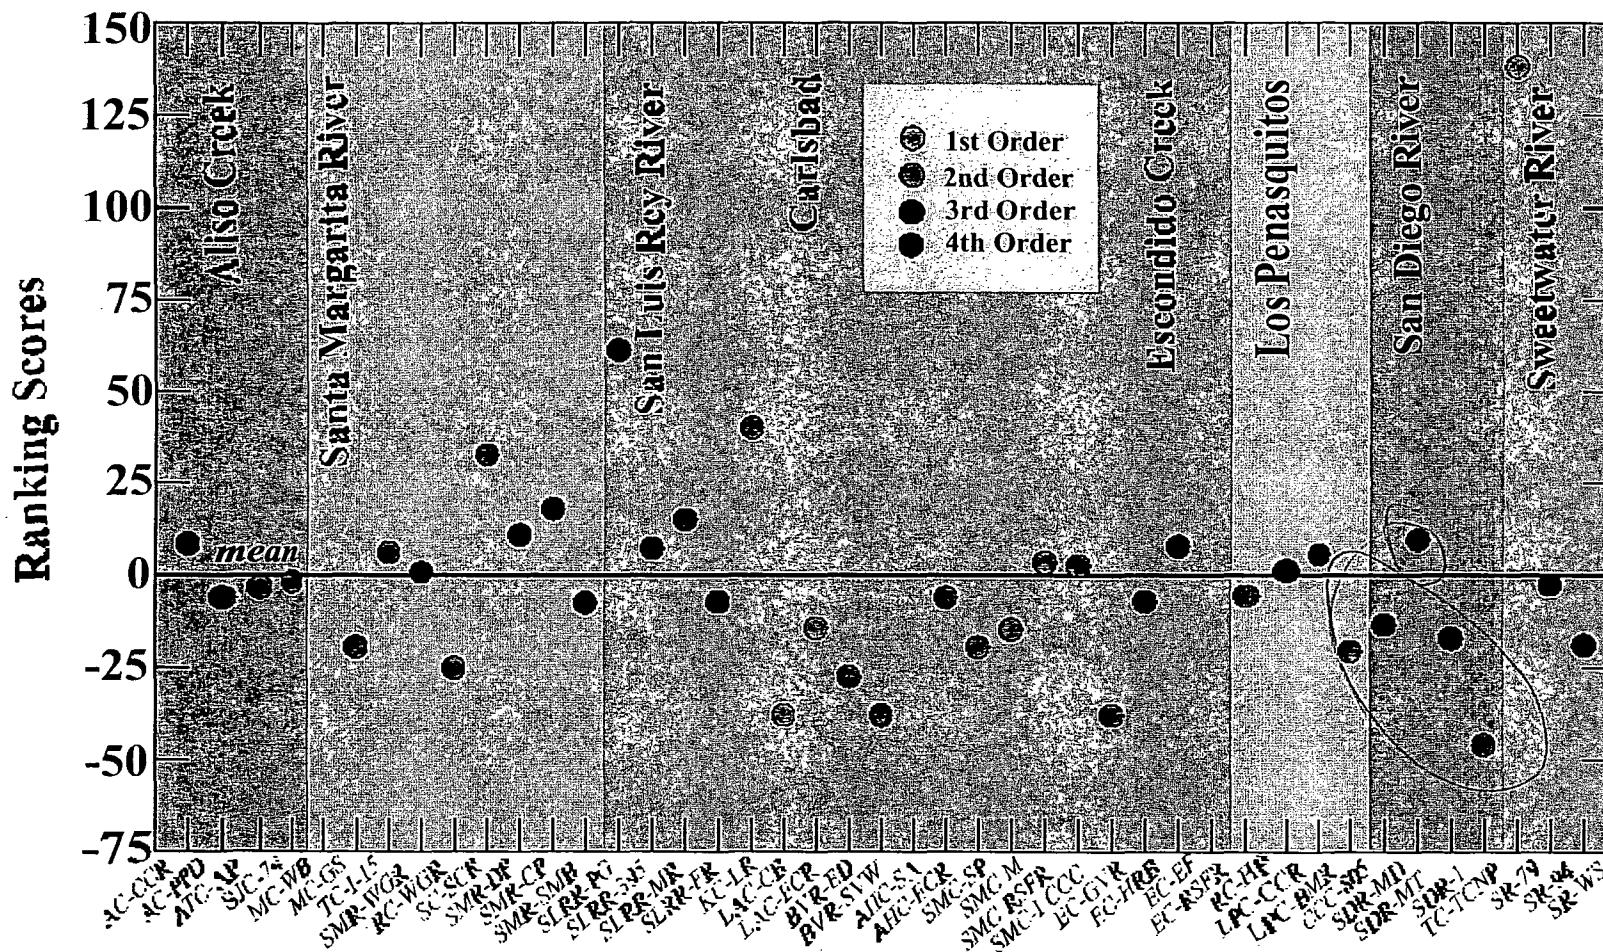
Figure 3d. BMI ranking scores for macroinvertebrate monitoring sites sampled in May 99 for the San Diego Regional Bioassessment Monitoring Project.

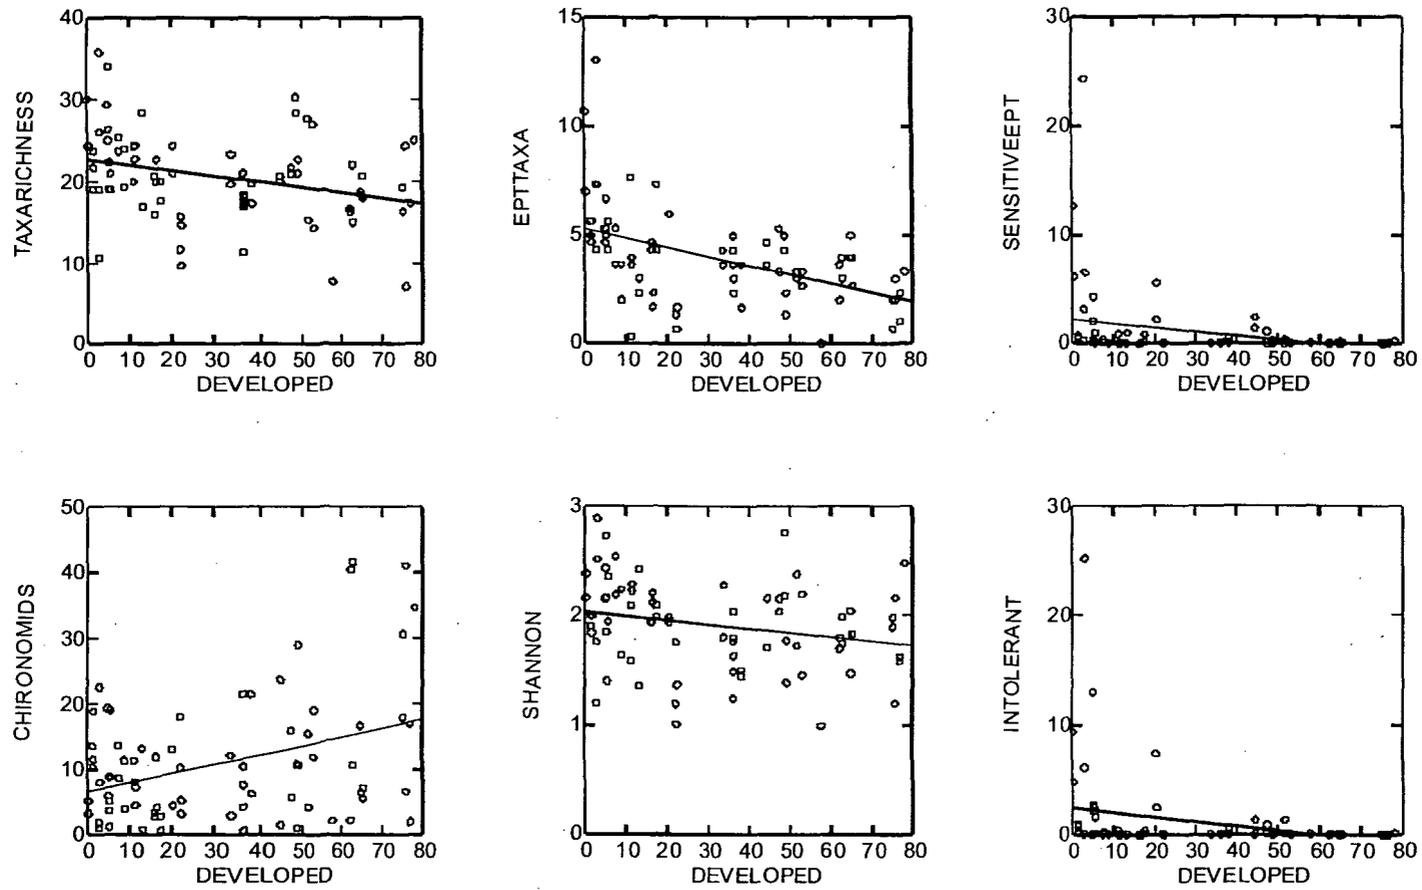
Figure 4. Relationship between major bioassessment metrics and the percentage of developed land in each watershed. Slopes of best fit lines do not imply statistical significance. See Appendix VII for explanation of axes.

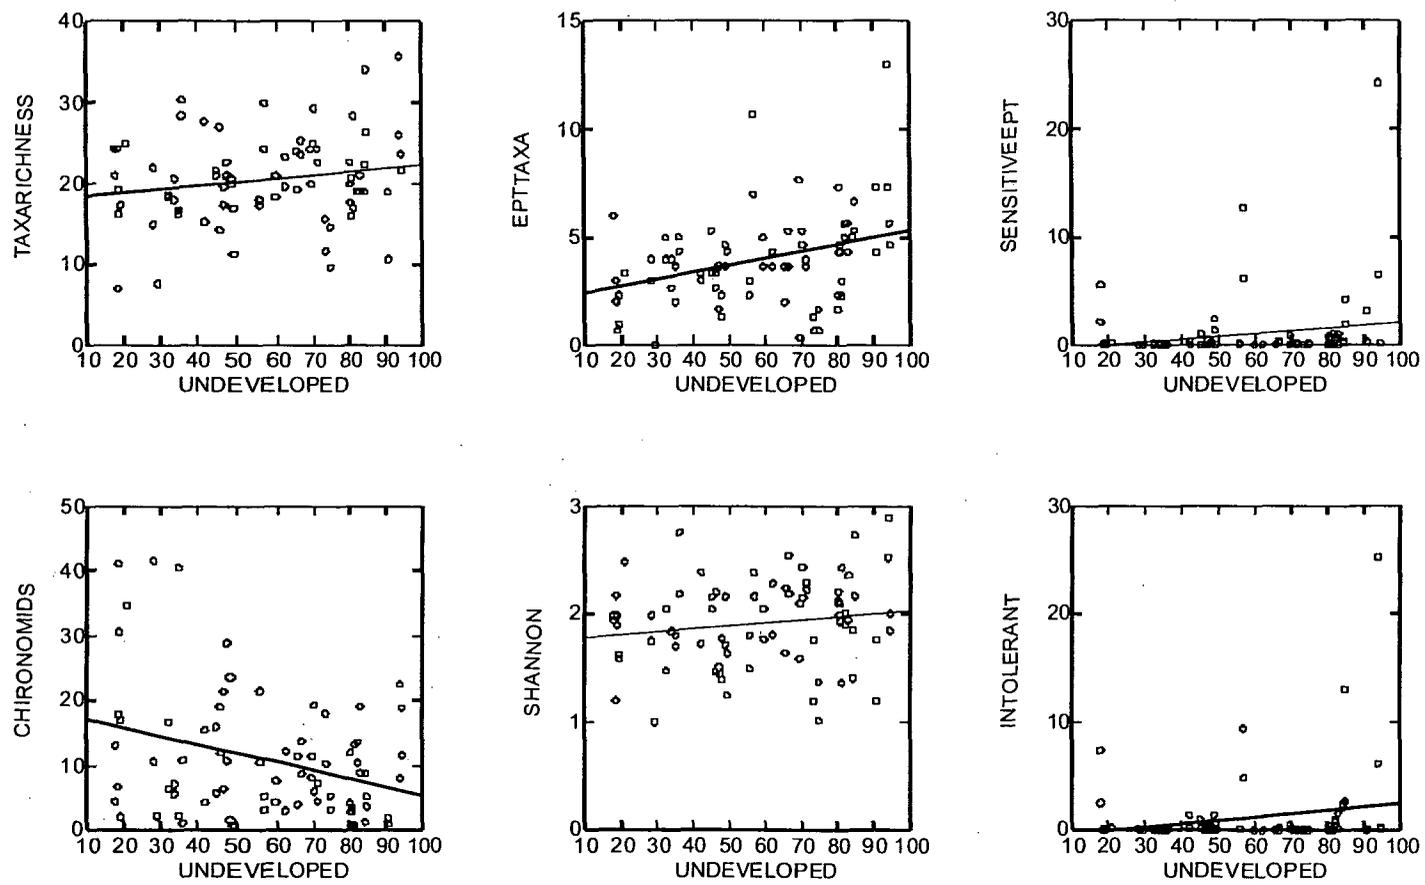
Figure 5. Relationship between major bioassessment metrics and the percentage of undeveloped land in each watershed. Slopes of best fit lines do not imply statistical significance. See Appendix VII for explanation of axes.

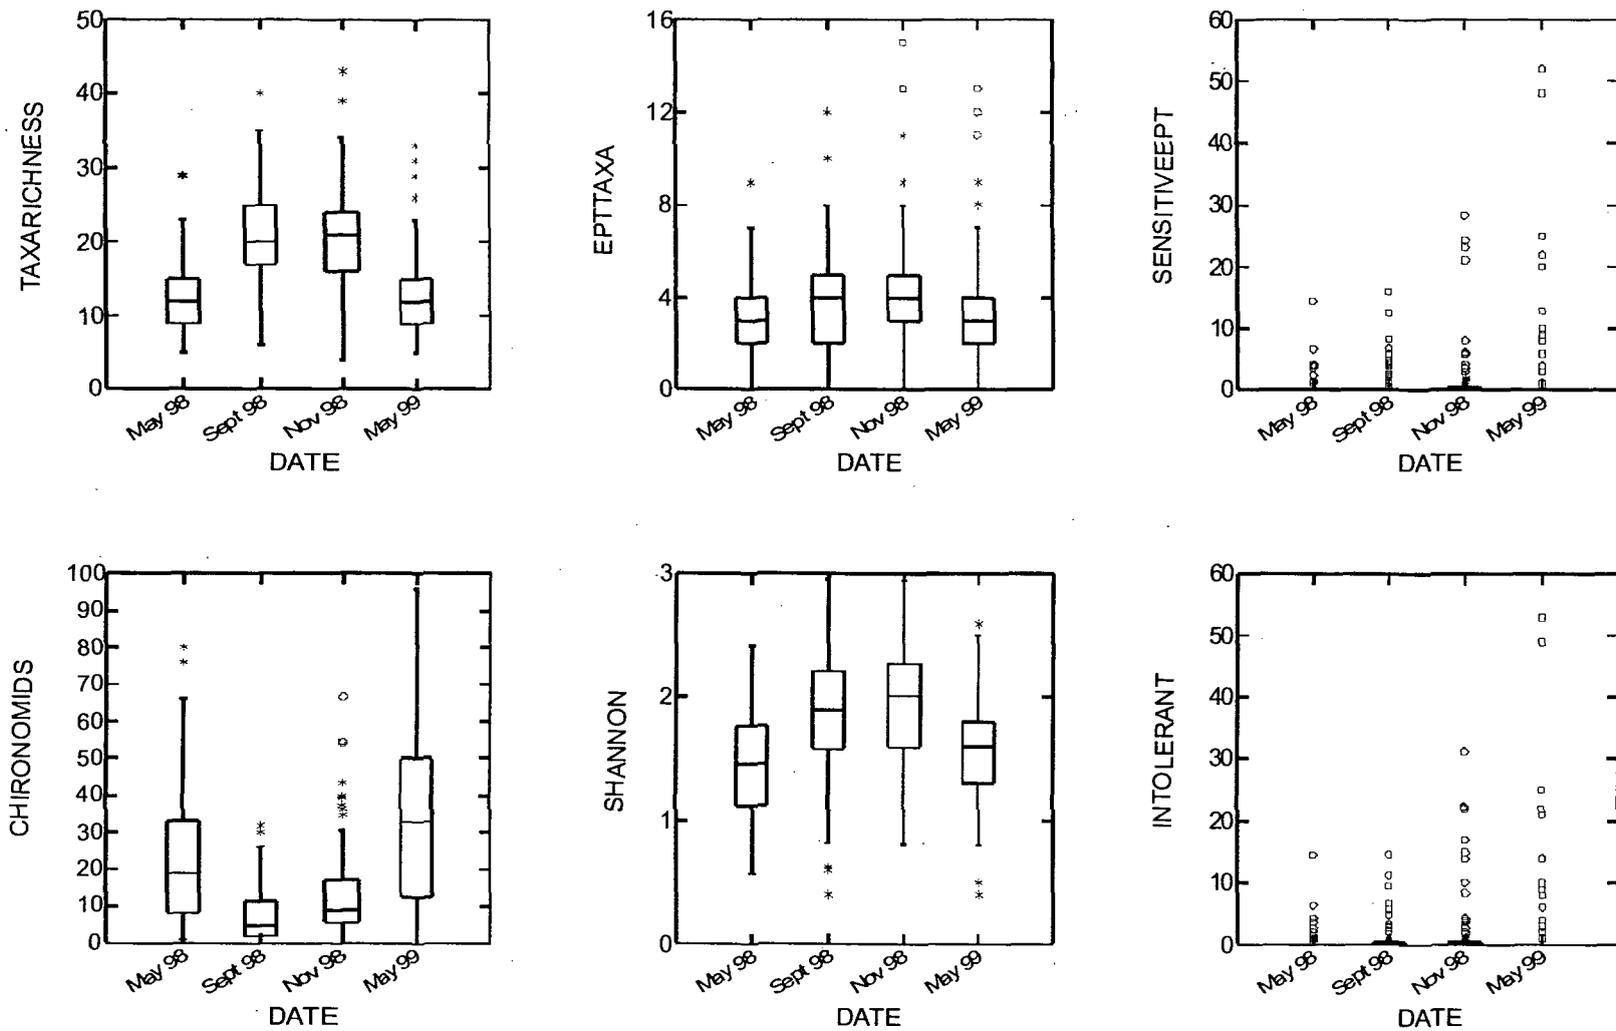
Figure 6. Boxplots describing the relationship between major bioassessment metrics and sampling date. See Appendix VII for an explanation of axes.

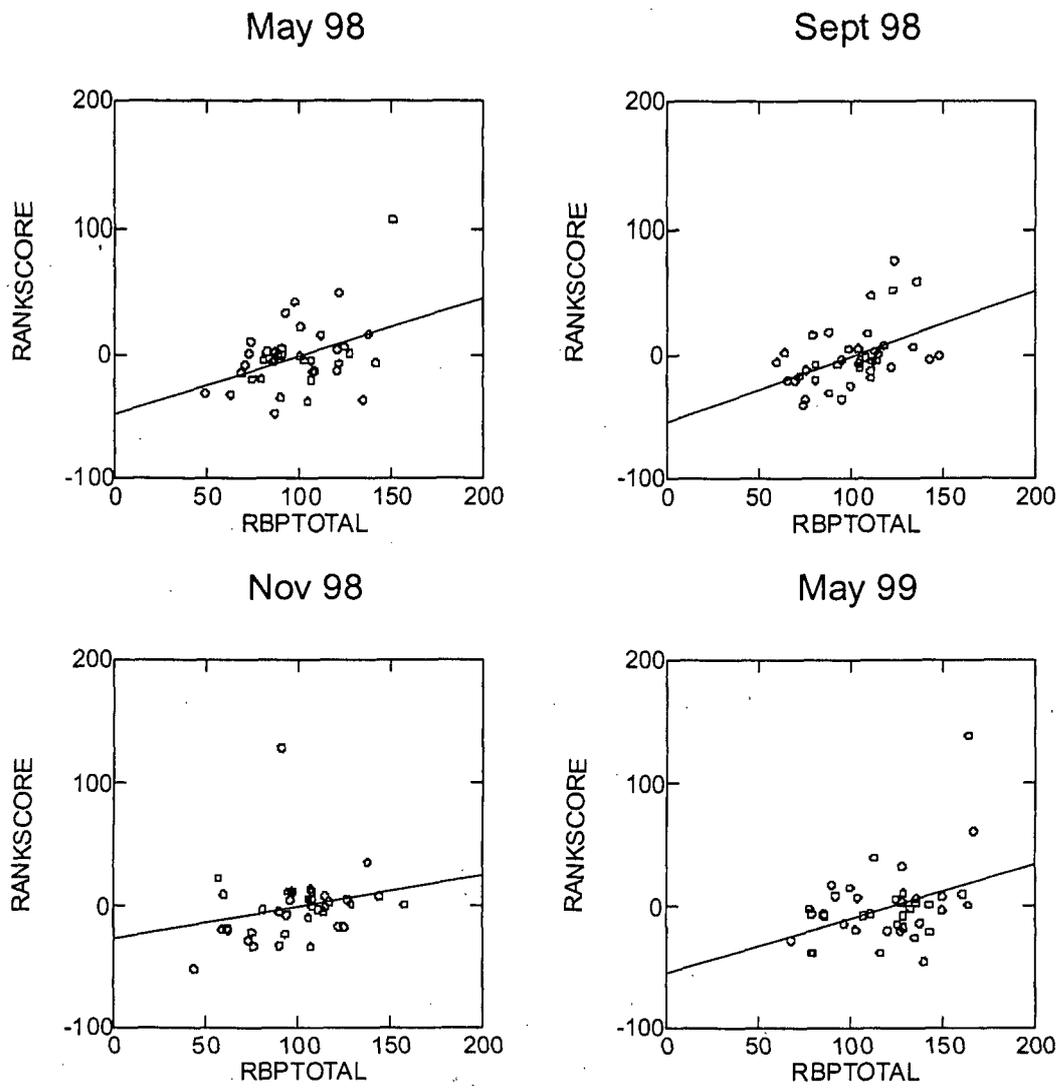
Figure 7. Relationship between physical/ habitat scores and the ranking scores of sites in the San Diego region. Slopes of best fit lines do not imply statistical significance. See Appendix VII for explanation of axes.

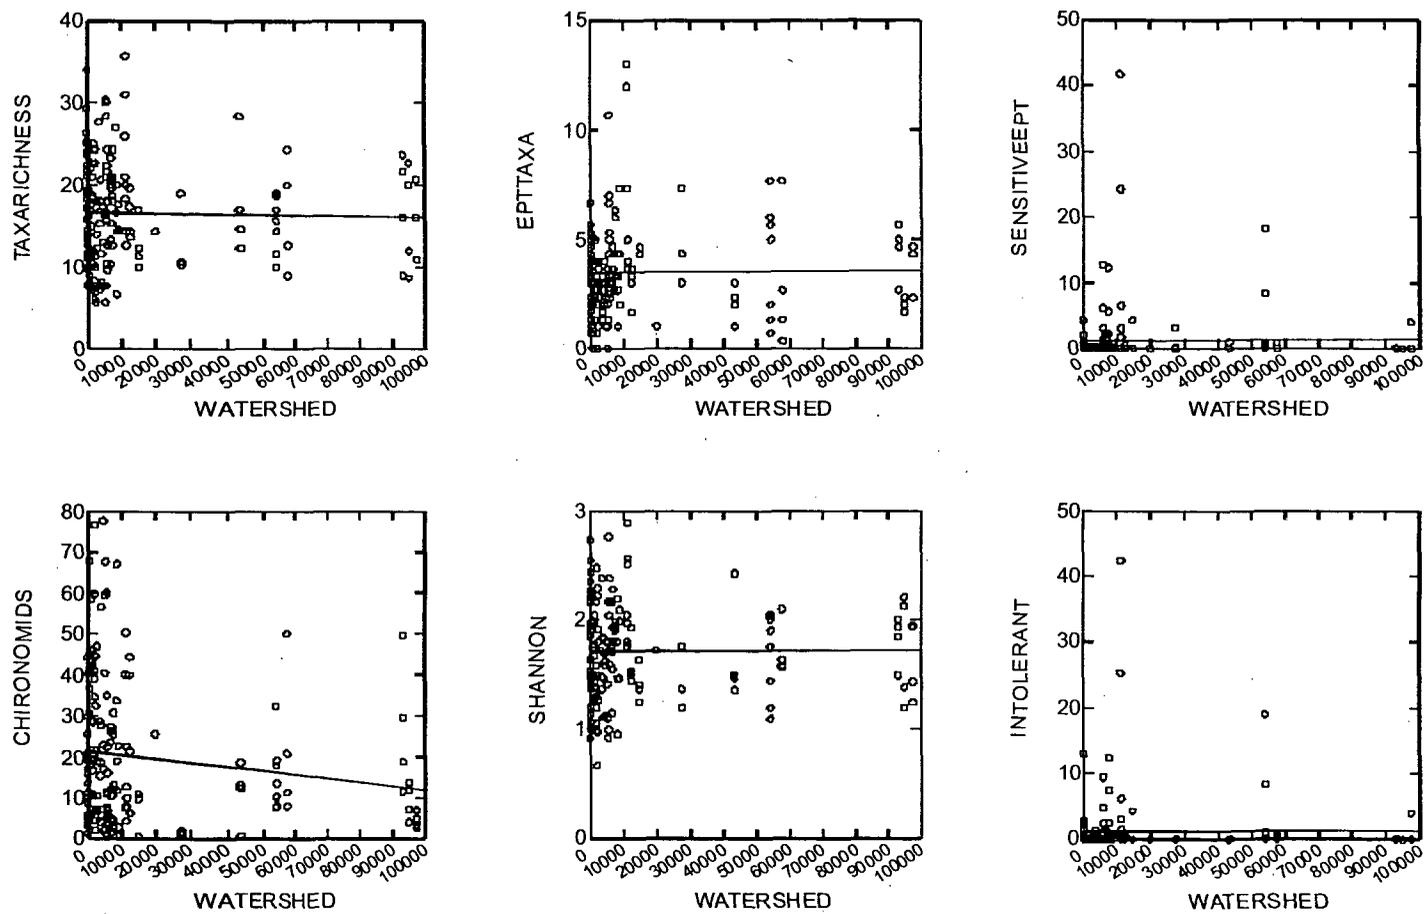
Figure 8. Relationship between major bioassessment metrics and the area encompassed by each watershed. Watershed areas are expressed in square coverage units $\times 10^4$. See Appendix VII for explanation of axes.

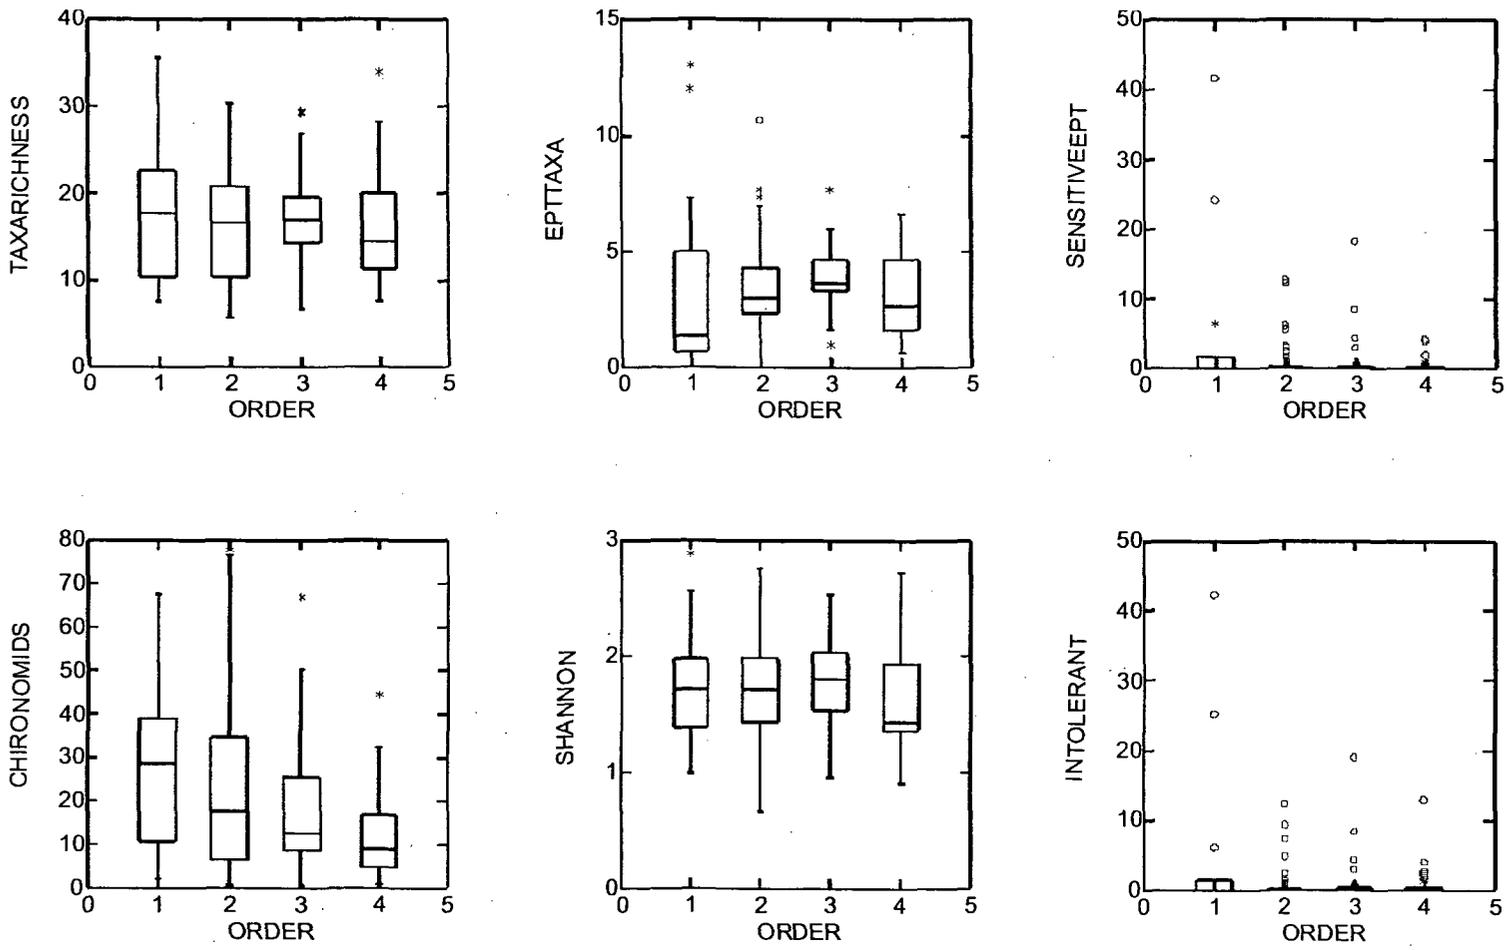
Figure 9. Relationship between major bioassessment metrics and the stream order at each site. See Appendix VII for explanation of axes.
